HSCA VII

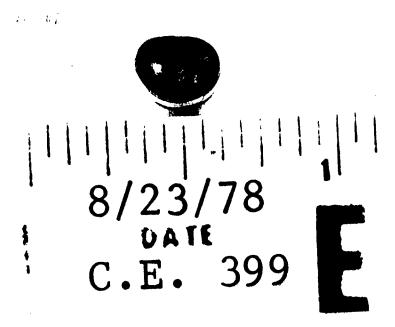
FIGURE 6B.—CE 399, the fired 6.5-millimeter caliber full metal-jacketed bullet found on a stretcher in the emergency area of Parkland Memorial Hospital, view of the base portion, showing distortion.
